Project report for the British Sub-Aqua Jubilee Trust

# Project Baseline Midland Pools

10<sup>th</sup> November 2021

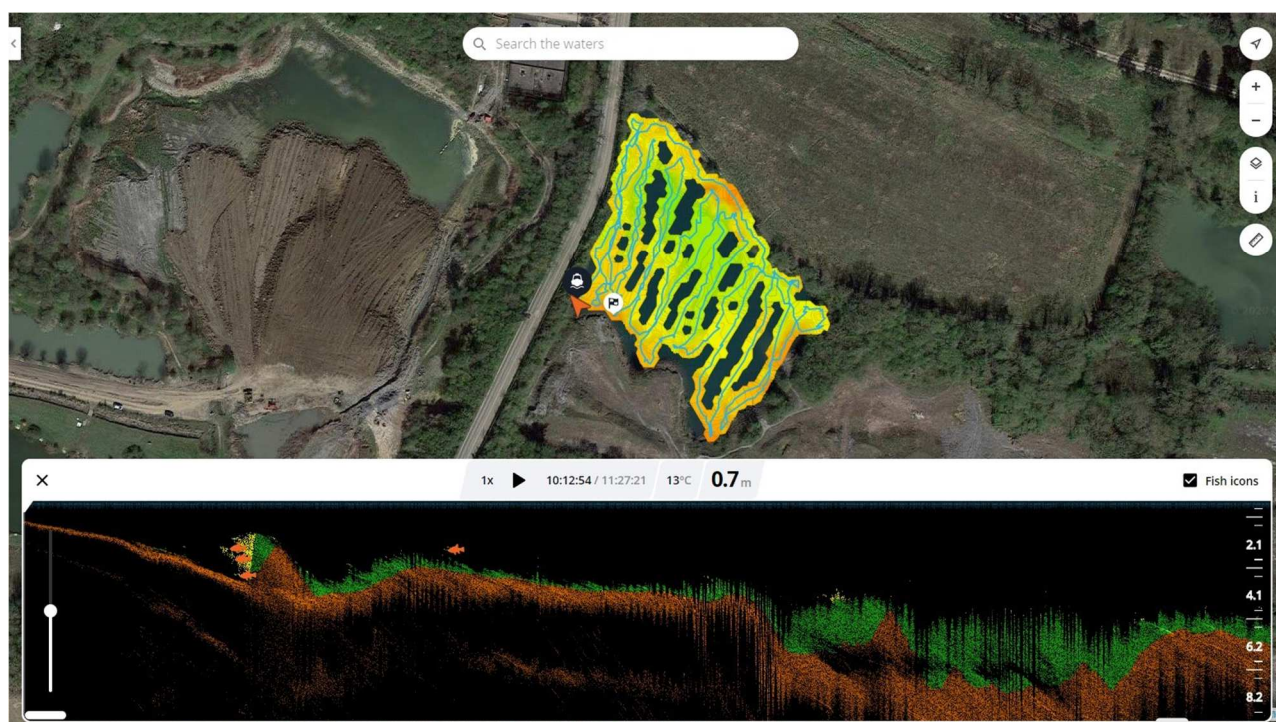
Figure 36 Blue Pool bathymetry data showing the route of the kayak across the water (blue line overlaying the map) and a depth profile (insert below).

The result at Blue Pool aligns well with that recorded by the sonar.

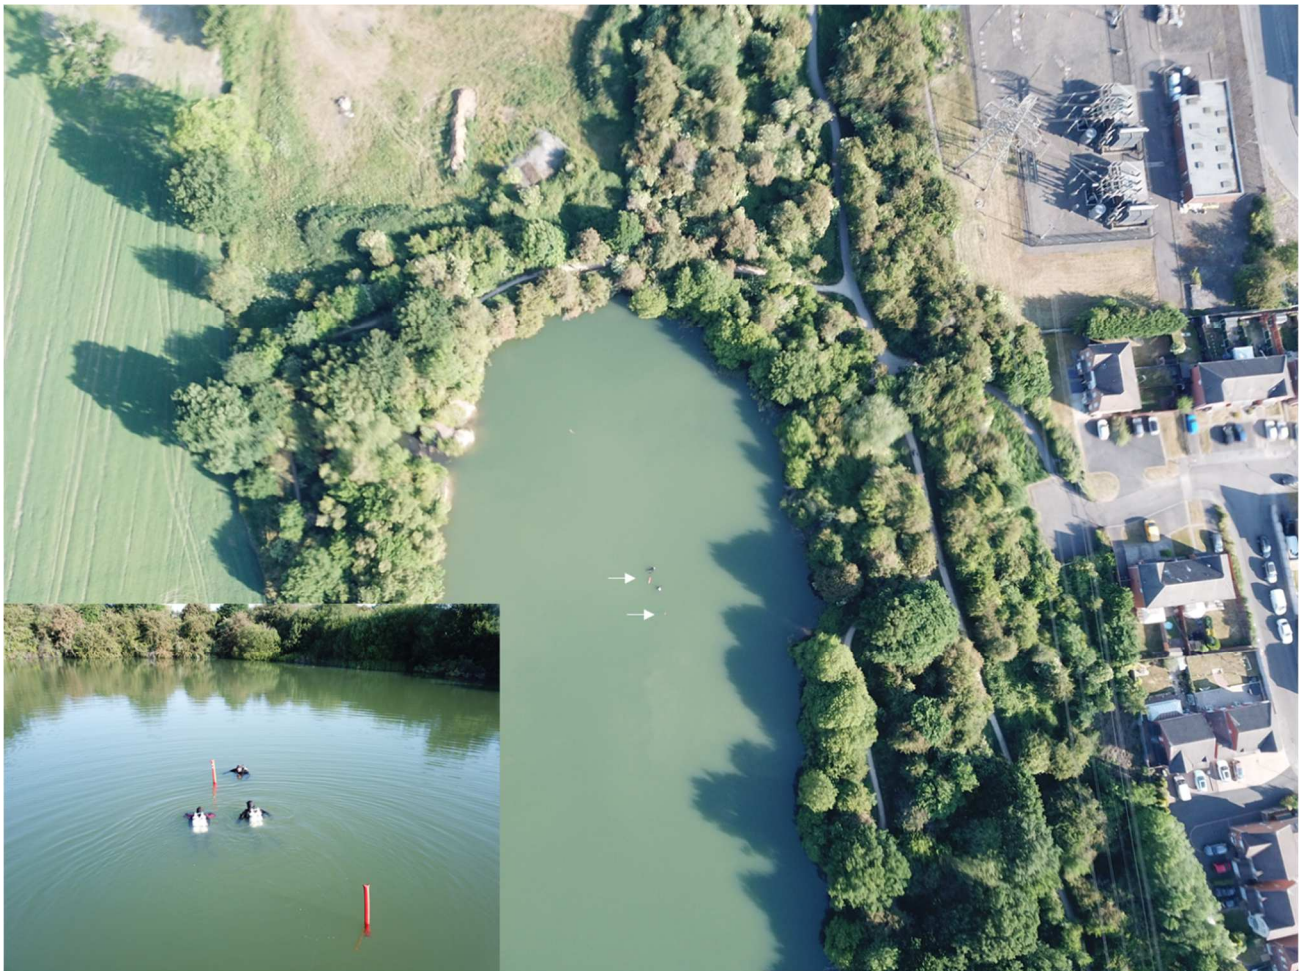
Figure 38 Ensor's Pool (north-west at top of image) showing its location next to agricultural land, grassland and a housing estate to the east. The location of two submerged standing telegraph poles was temporarily marked by orange buoys (main image, white arrows and insert). The top 1–2 m of water is silty having been stirred up by swimmers over several days prior to the fieldwork.

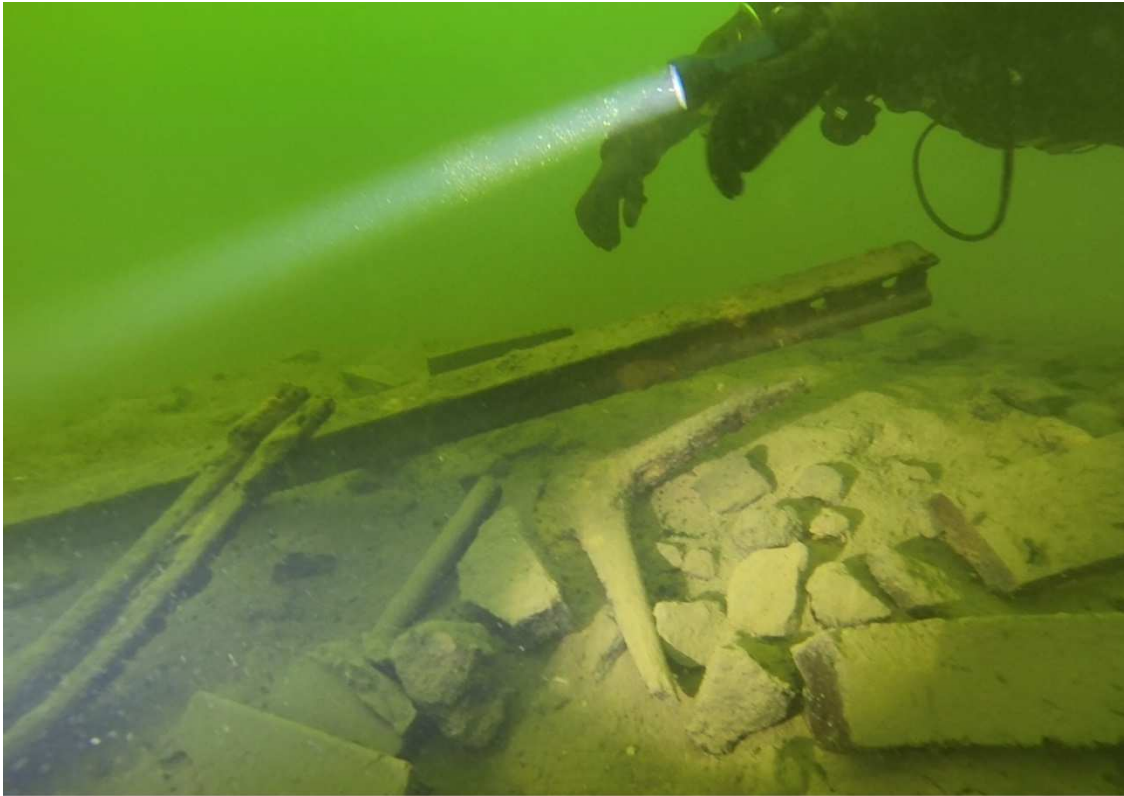
Figure 39 Diver examines artifacts in Ensor's Pool including a pickaxe head and tub rail. Rails may be stamped with a date of manufacture but this was not observed on the rails examined.

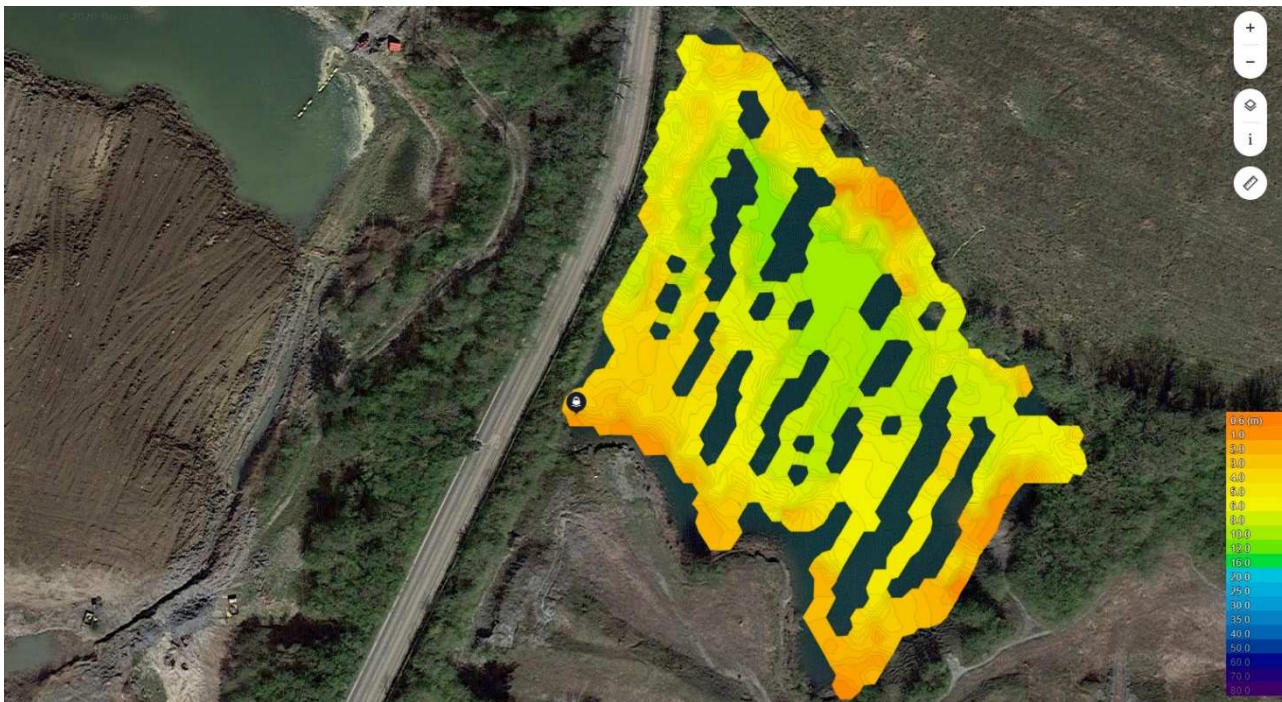
Figure 45 Blue Pool bathymetry data processed at high resolution, overlaid over a satellite map (Google) and colour coded to show shallow depths in orange and deeper areas in green. Gaps in the dataset are apparent.

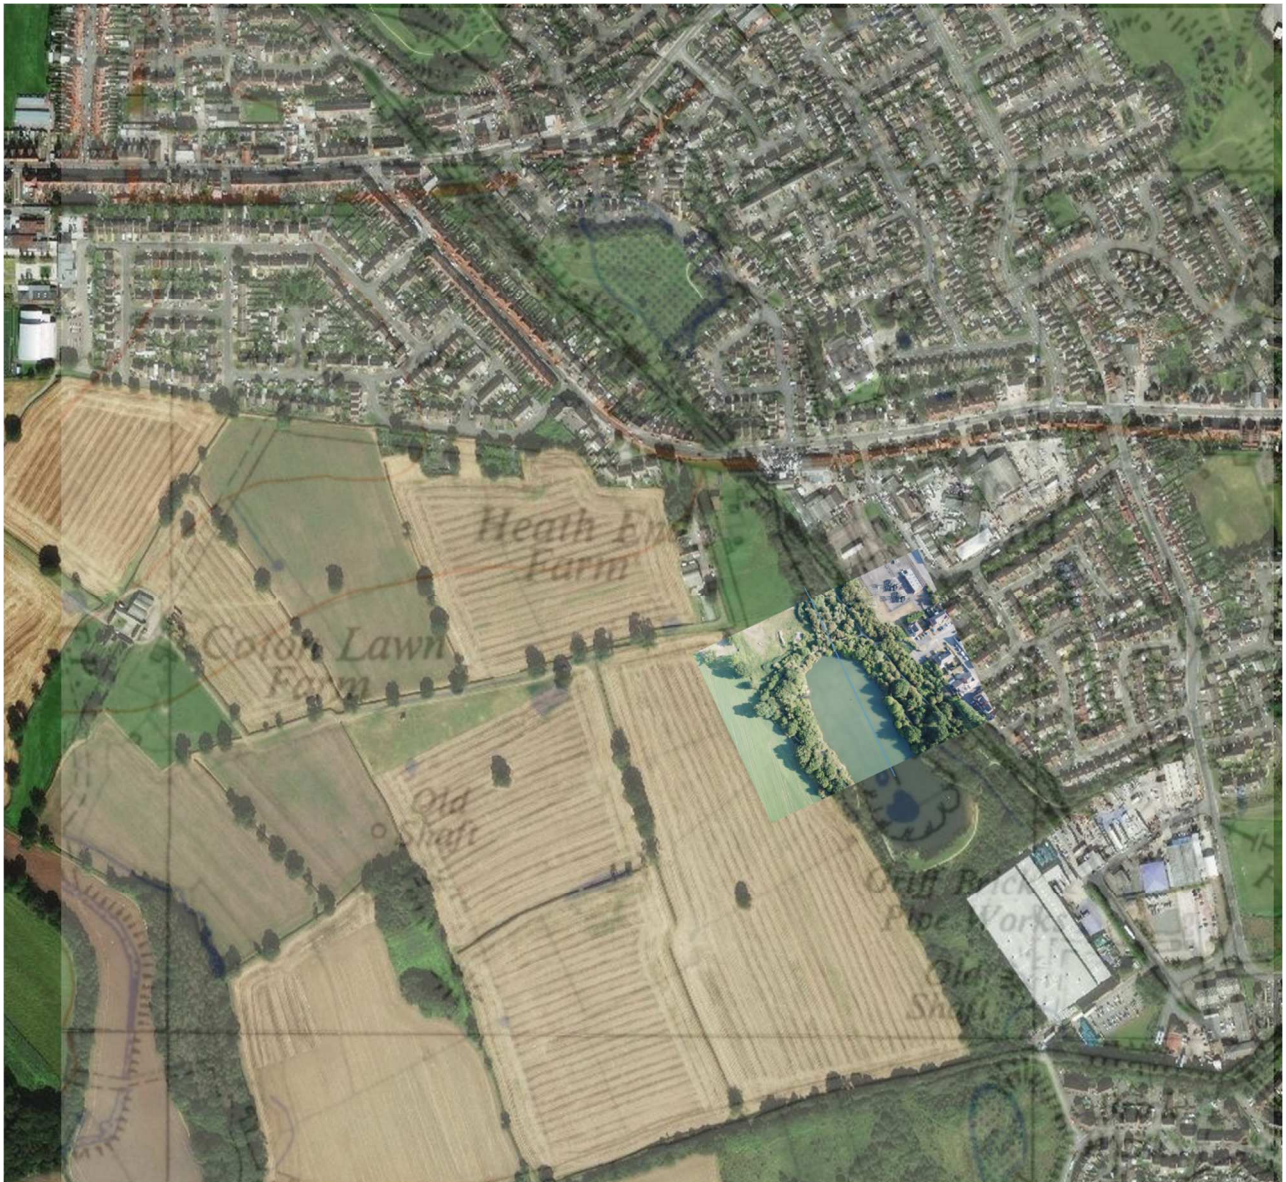
Figure 47 Combining the map of Ensor's Pool from Figure 6, the drone image from Figure 38, and a modern satellite image helps identify the trackway (blue line) that remains within the water close to the two telegraph poles.

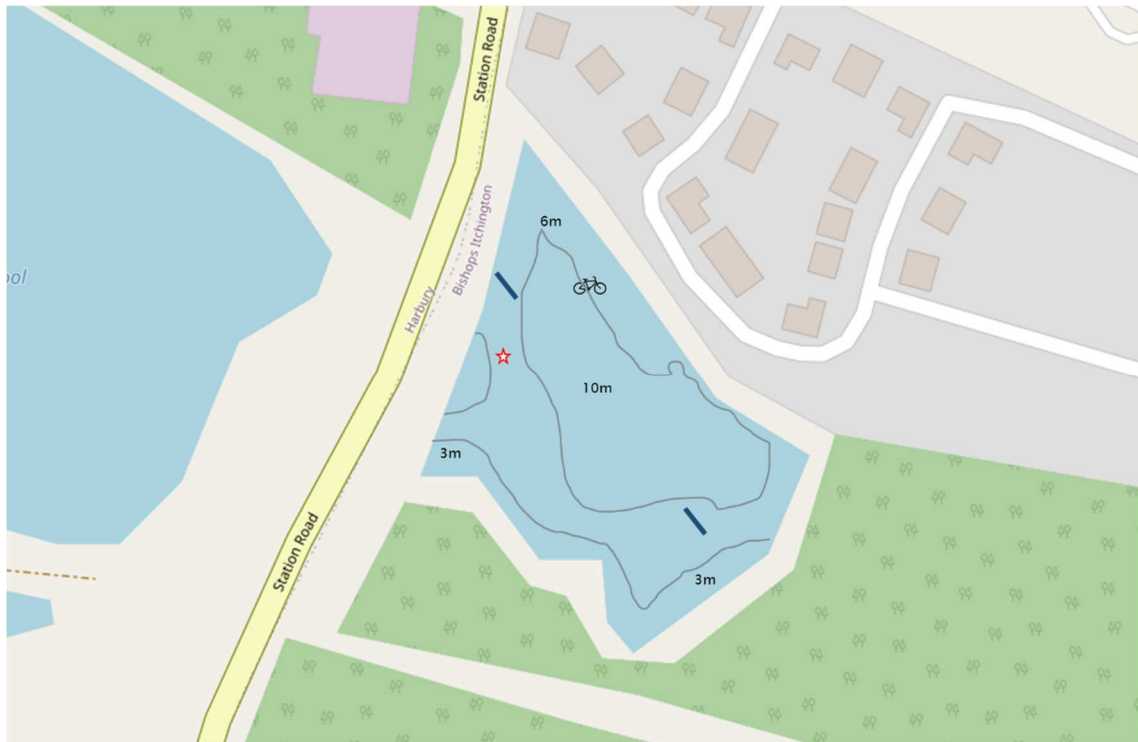
Figure 50 Sketch map of Blue Pool based on diver observations and bathymetry showing the remains of iron rails (blue lines). The location of the monitoring station is marked by a red star. [31]

Sketch maps were also prepared from diver observations at Ensor's Pool (Figure 48), Newbold Quarry (Figure 49), Blue Pool (Figure 50), Great Pit (Figure 51) and Hill Hole Quarry (Figure 52).
